## CORRECTIVE ACTION STABILIZATION QUESTIONNAIRE

Facility Name: Detrex Corporation

**Technical Enforcement Support  
at Hazardous Waste Sites  
Zone III  
Regions 5,6, and 7**

PRC Environmental Management, Inc. (PRC), performed a preliminary assessment and visual site inspection (PA/VSI) to identify and assess the existence and likelihood of releases from solid waste management units (SWMU) and other areas of concern (AOC) at the Detrex Corporation Gold Shield Division (Gold Shield) facility in Grand Rapids, Michigan. This summary highlights the results of the PA/VSI and the potential for releases of hazardous wastes or hazardous constituents from SWMUs identified.

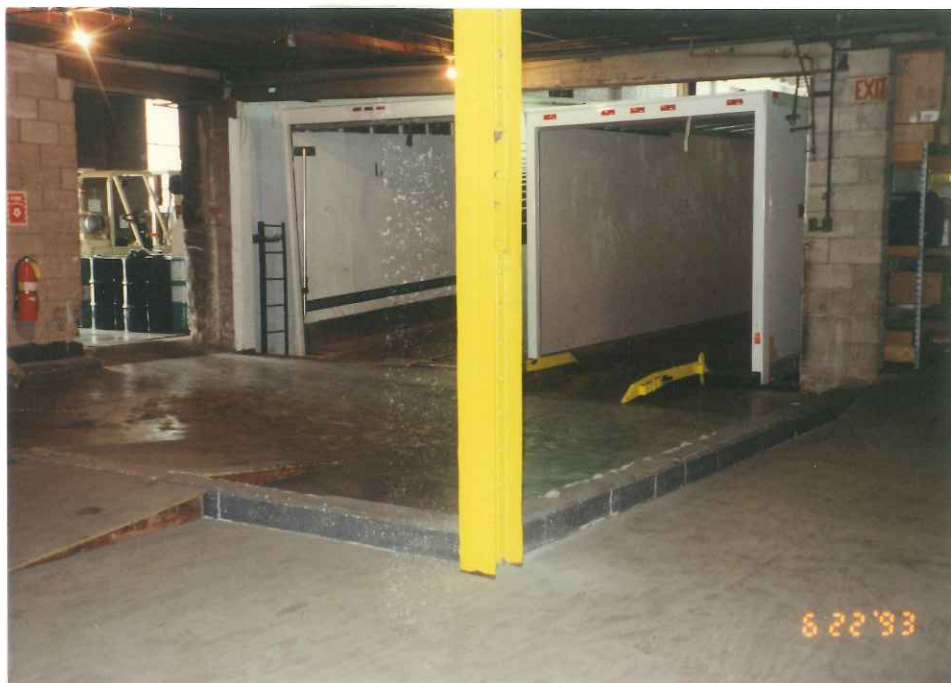
Photograph No. 1

**Observations:** The concrete in the dock area and the loading area was in good condition and free of cracks. No drums were present in the trailers during the VSI. PRC noted dark staining around the grated drain at the top of the ramp (see Photograph Nos. 1, 8, and 13).

Description: Area of Transfer Facility (SWMU 7) and Former Waste Handling Area (SWMU 6);  
two trailers parked on ramp for 10-day drum storage

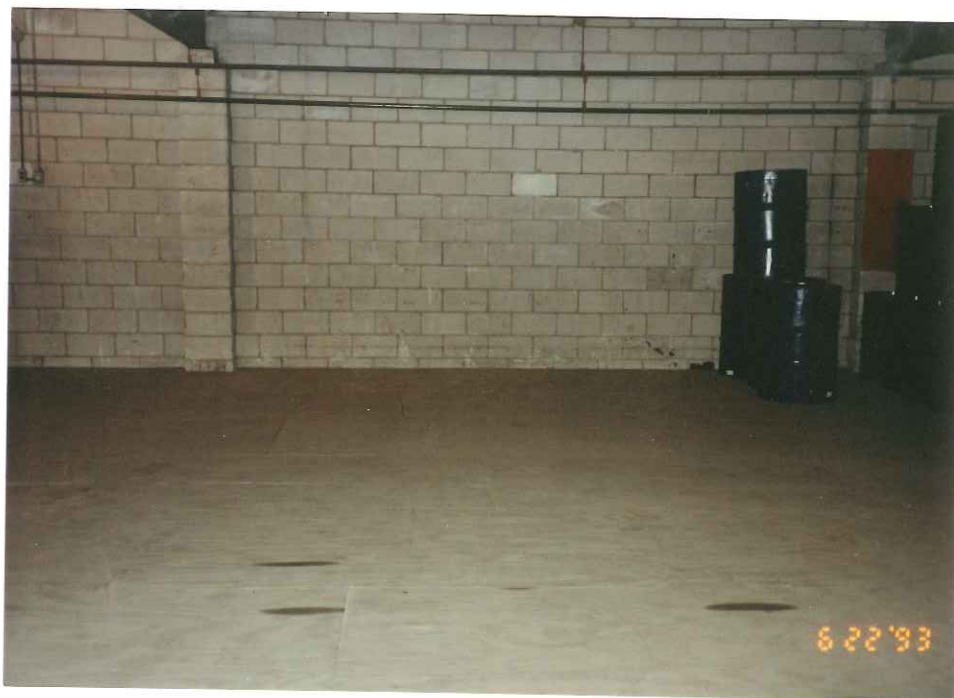
This SWMU has been removed. However, the basement is still in existence. PRC noted staining on the ceiling, walls, and floor of the basement. The hardwood floor of the unit was also still present and at the time of the VSI, product solvents were stored there (see Photograph No. 2 and 5).

Description: Former Drum Storage Area No. 3 for spent solvents

**Recommendations:** PRC recommends that the facility continue closure activities as required by MDNR.

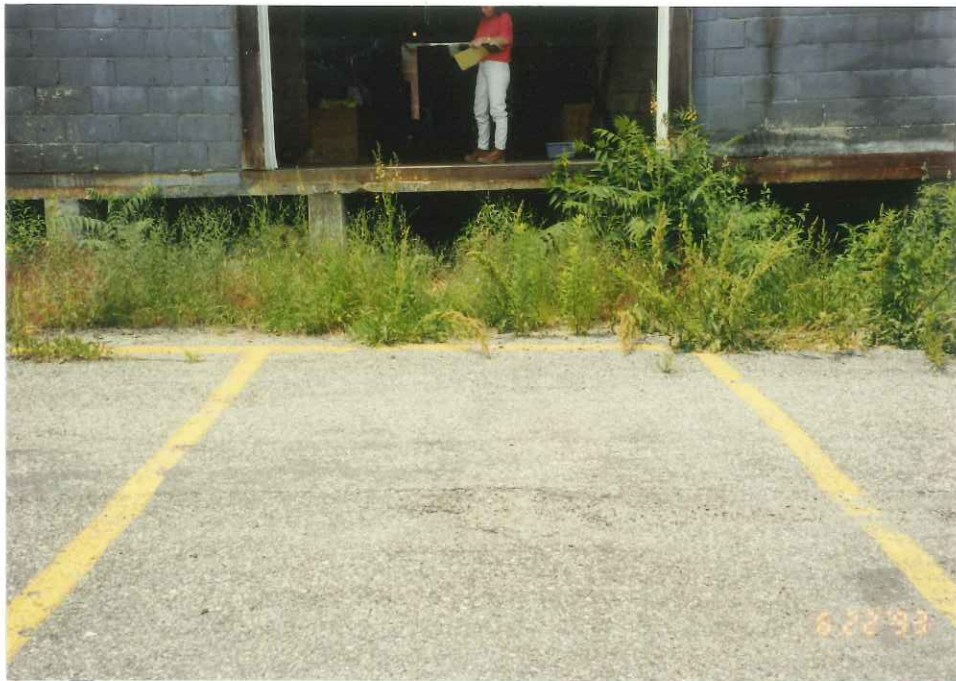
**Photograph No. 3**

**Observations:** This area was covered with grass. PRC observed no evidence of release. (See Photograph Nos. 3 and 4).

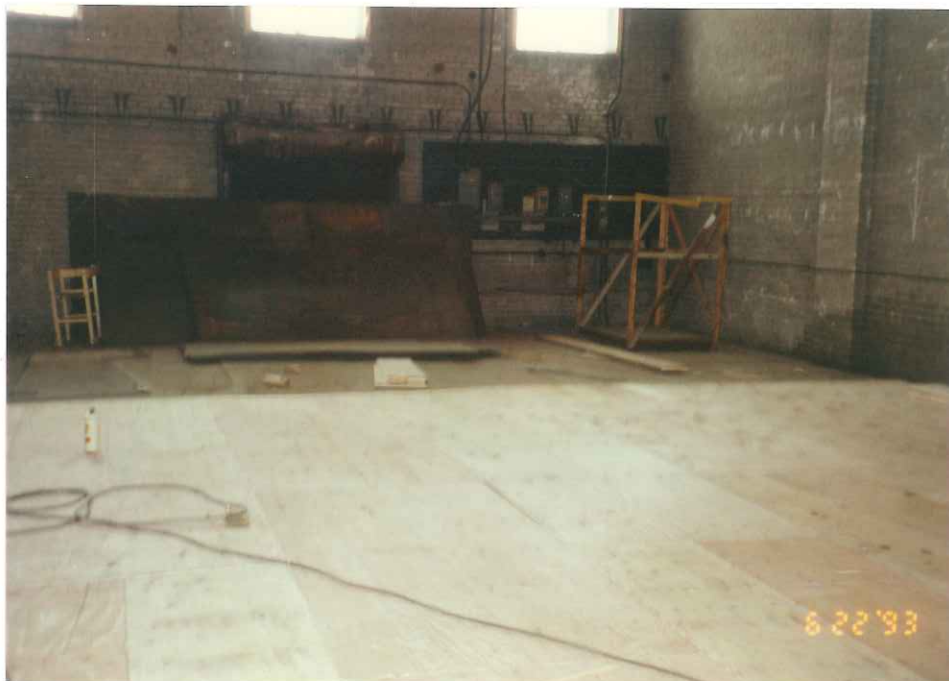
Photograph No. 7

**Observations:** This SWMU has been removed. However, the basement is still in existence. PRC noted staining on the ceiling, walls, and floor of the basement. The hardwood floor of the former SWMU was being replaced at the time of the VSI (see Photograph No. 7).

Description: Former Drum Storage Area No. 2; presently undergoing floor replacement

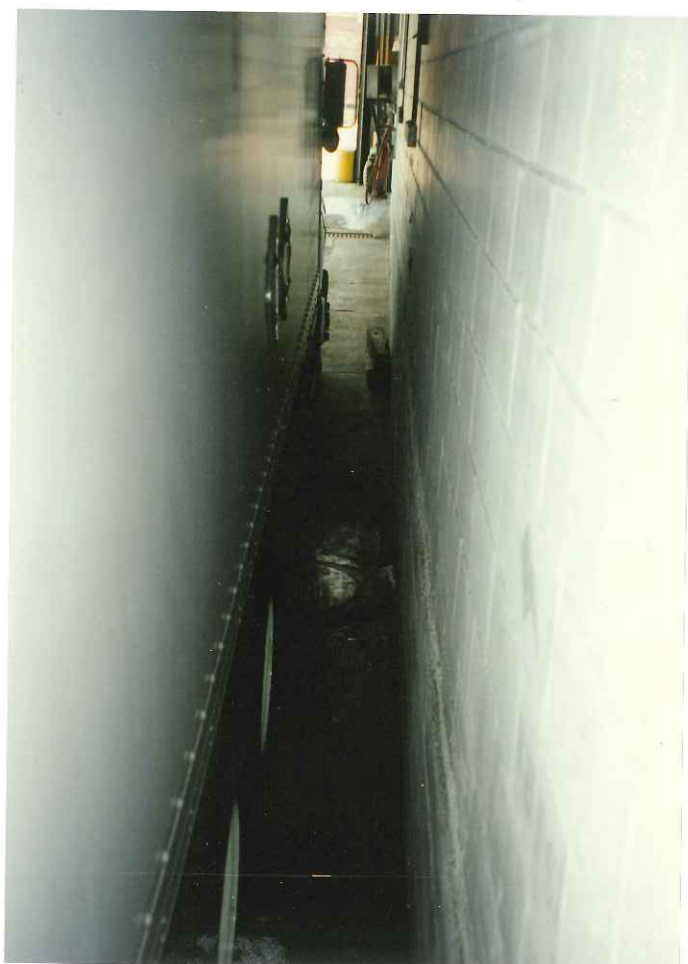
Photograph No. 8

Description: Close-up of closed sump in loading ramp of Transfer Facility (SWMU 7)

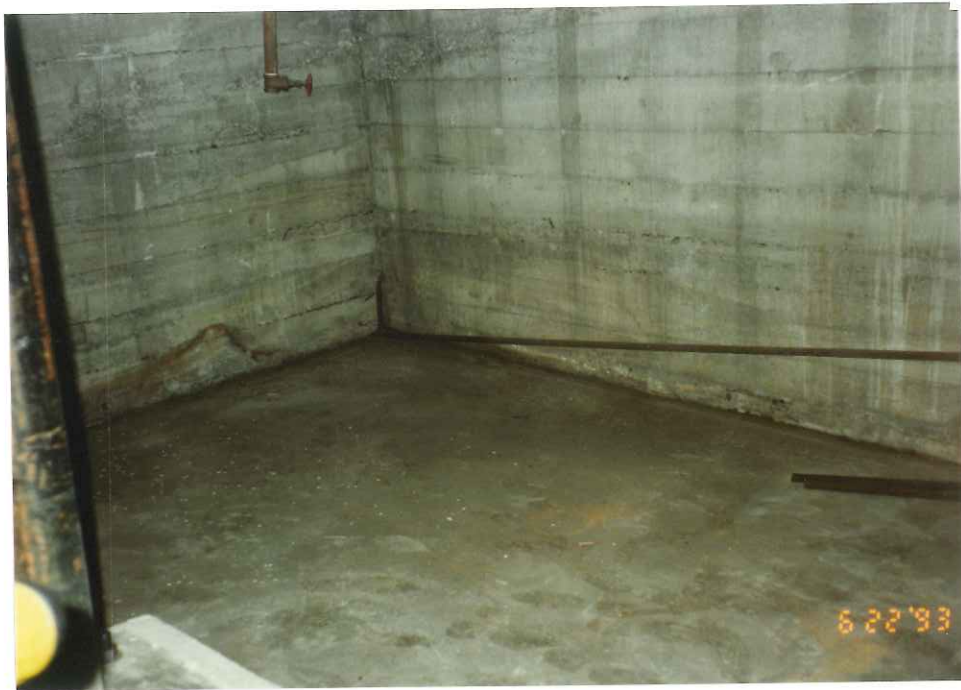
Photograph No. 9

**Observations:** This SWMU has been removed. However, the basement is still in existence. PRC noted extensive staining on the ceiling, walls, and floor of the basement (see Photograph No. 9).

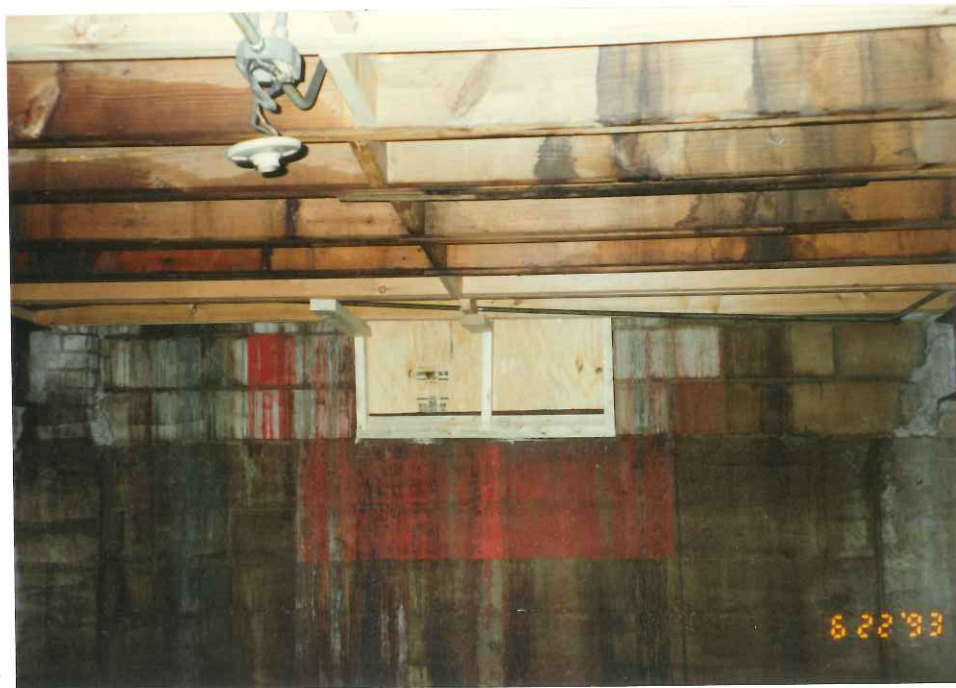
Photograph No. 10

**Observations:** This SWMU has been removed. However, the basement is still in existence. PRC noted staining on the ceiling, walls, and floor of the basement (see Photographs No. 10 and 11).

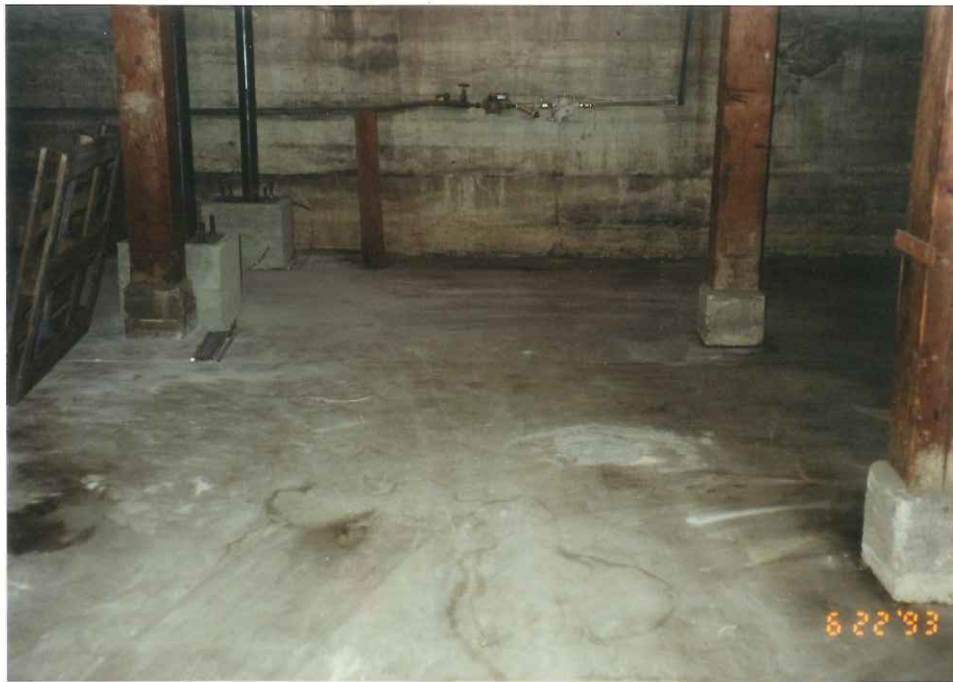
Photograph No. 11  
 Orientation: North  
 Description: Area of Former Still Bottom Storage Tanks

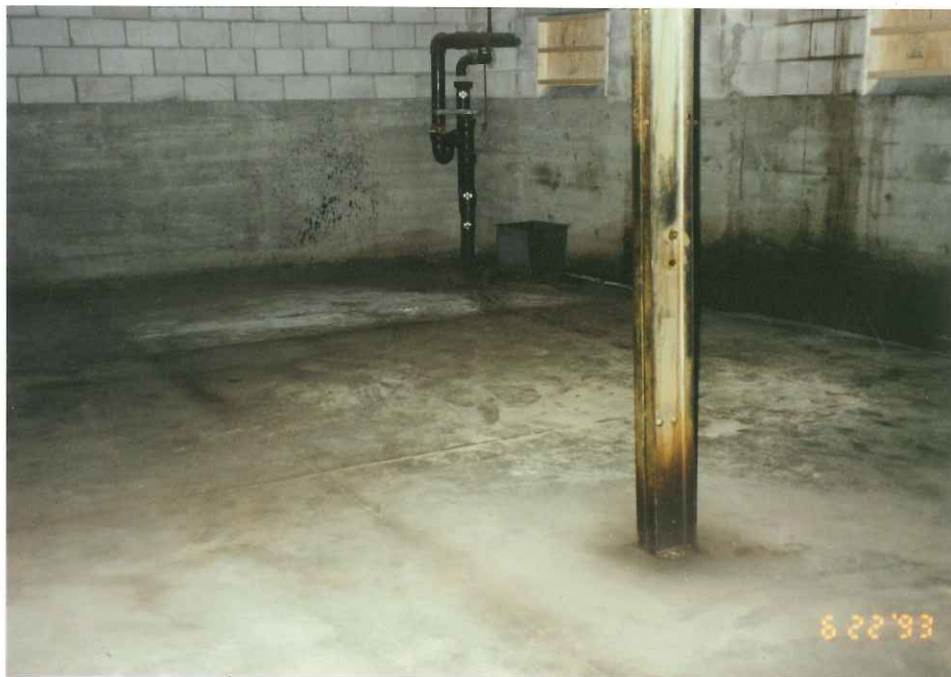
This unit had been removed. PRC noted no evidence of a release. (See Photograph No. 12).

Photograph No. 12  
 Orientation: North  
 Description: Former Drum Storage Area No. 4 (SWMU 9) in basement
